**OPTICAL INSTRUMENTATION
DATA EVALUATION
OF THE SA-204/LM-1 SATURN IB
LAUNCH VEHICLE**

Technical Report HSM-R302-68

L. F. Dennis
and
W. L. Cardwell

March 8, 1968

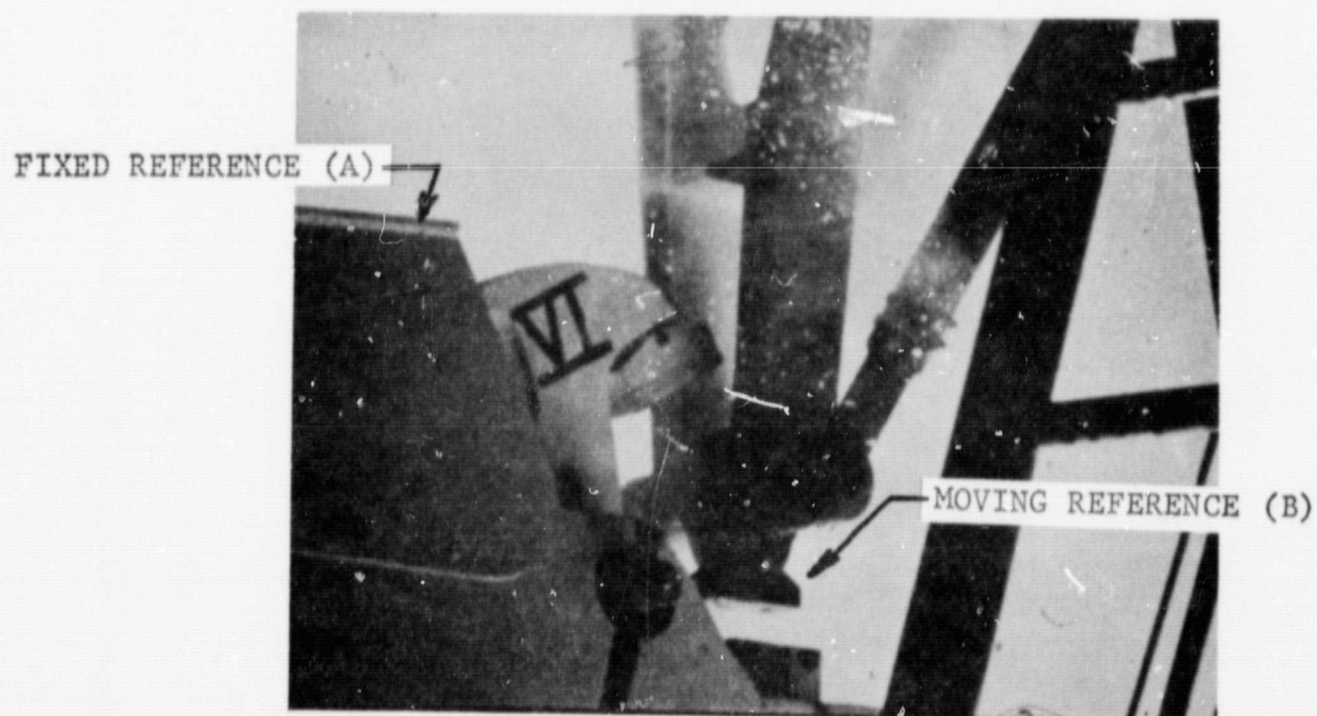
FIGURE 2. VEHICLE FIRST MOTION REFERENCE TARGETS ON HOLDDOWN ARMS

Two cameras were programmed to record vehicle first continuous motion. Both of the cameras produced usable film; however, the field of view was about 80 percent obscured by frost, ice, and smoke during the time first motion occurred. First motion was referenced to the first continuous motion of the targets (A) painted on the vehicle with reference to the fixed point (B) mounted on holddown arms II-III and IV-I (Figure 1). First motion was obtained from two other holddown arms as a further check of the data. The fin on the vehicle was used as the reference and a bolt head on the holddown arm as the fixed reference (Figure 2). These times matched within six milliseconds (Figures 3 and 4).

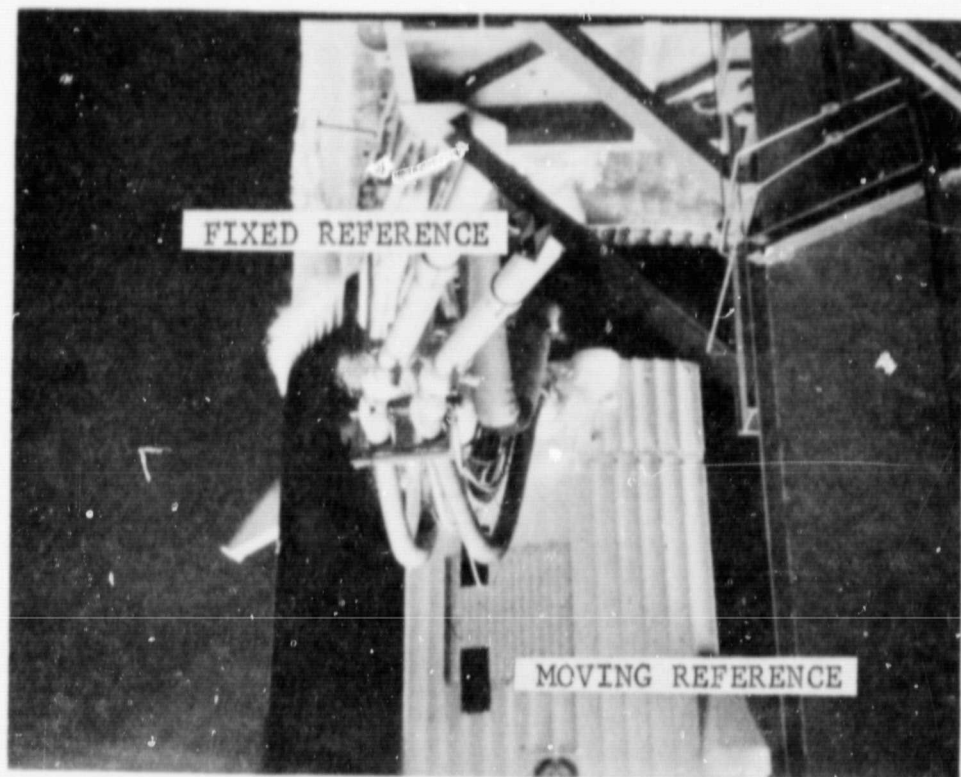
FIGURE 5. VEHICLE VERTICAL MOTION REFERENCE TARGETS

One camera (35mm Mitchell) was programmed to record vehicle vertical motion for the first three to five meters of flight. The power plug to this camera fell from its socket and the camera produced about seventy feet of usable film; the camera was oriented too high; and some of the targets were obscured by frost and ice. These three factors limited the coverage to 0.6 meters of flight from which the trend of vertical motion and vertical velocity was established. A reference scheme of markers on the vehicle (A) and a fixed target on umbilical tower (B) were used to acquire the necessary data for the 0.6 meters of vertical motion and velocity (Figures 5, 6, and 7).

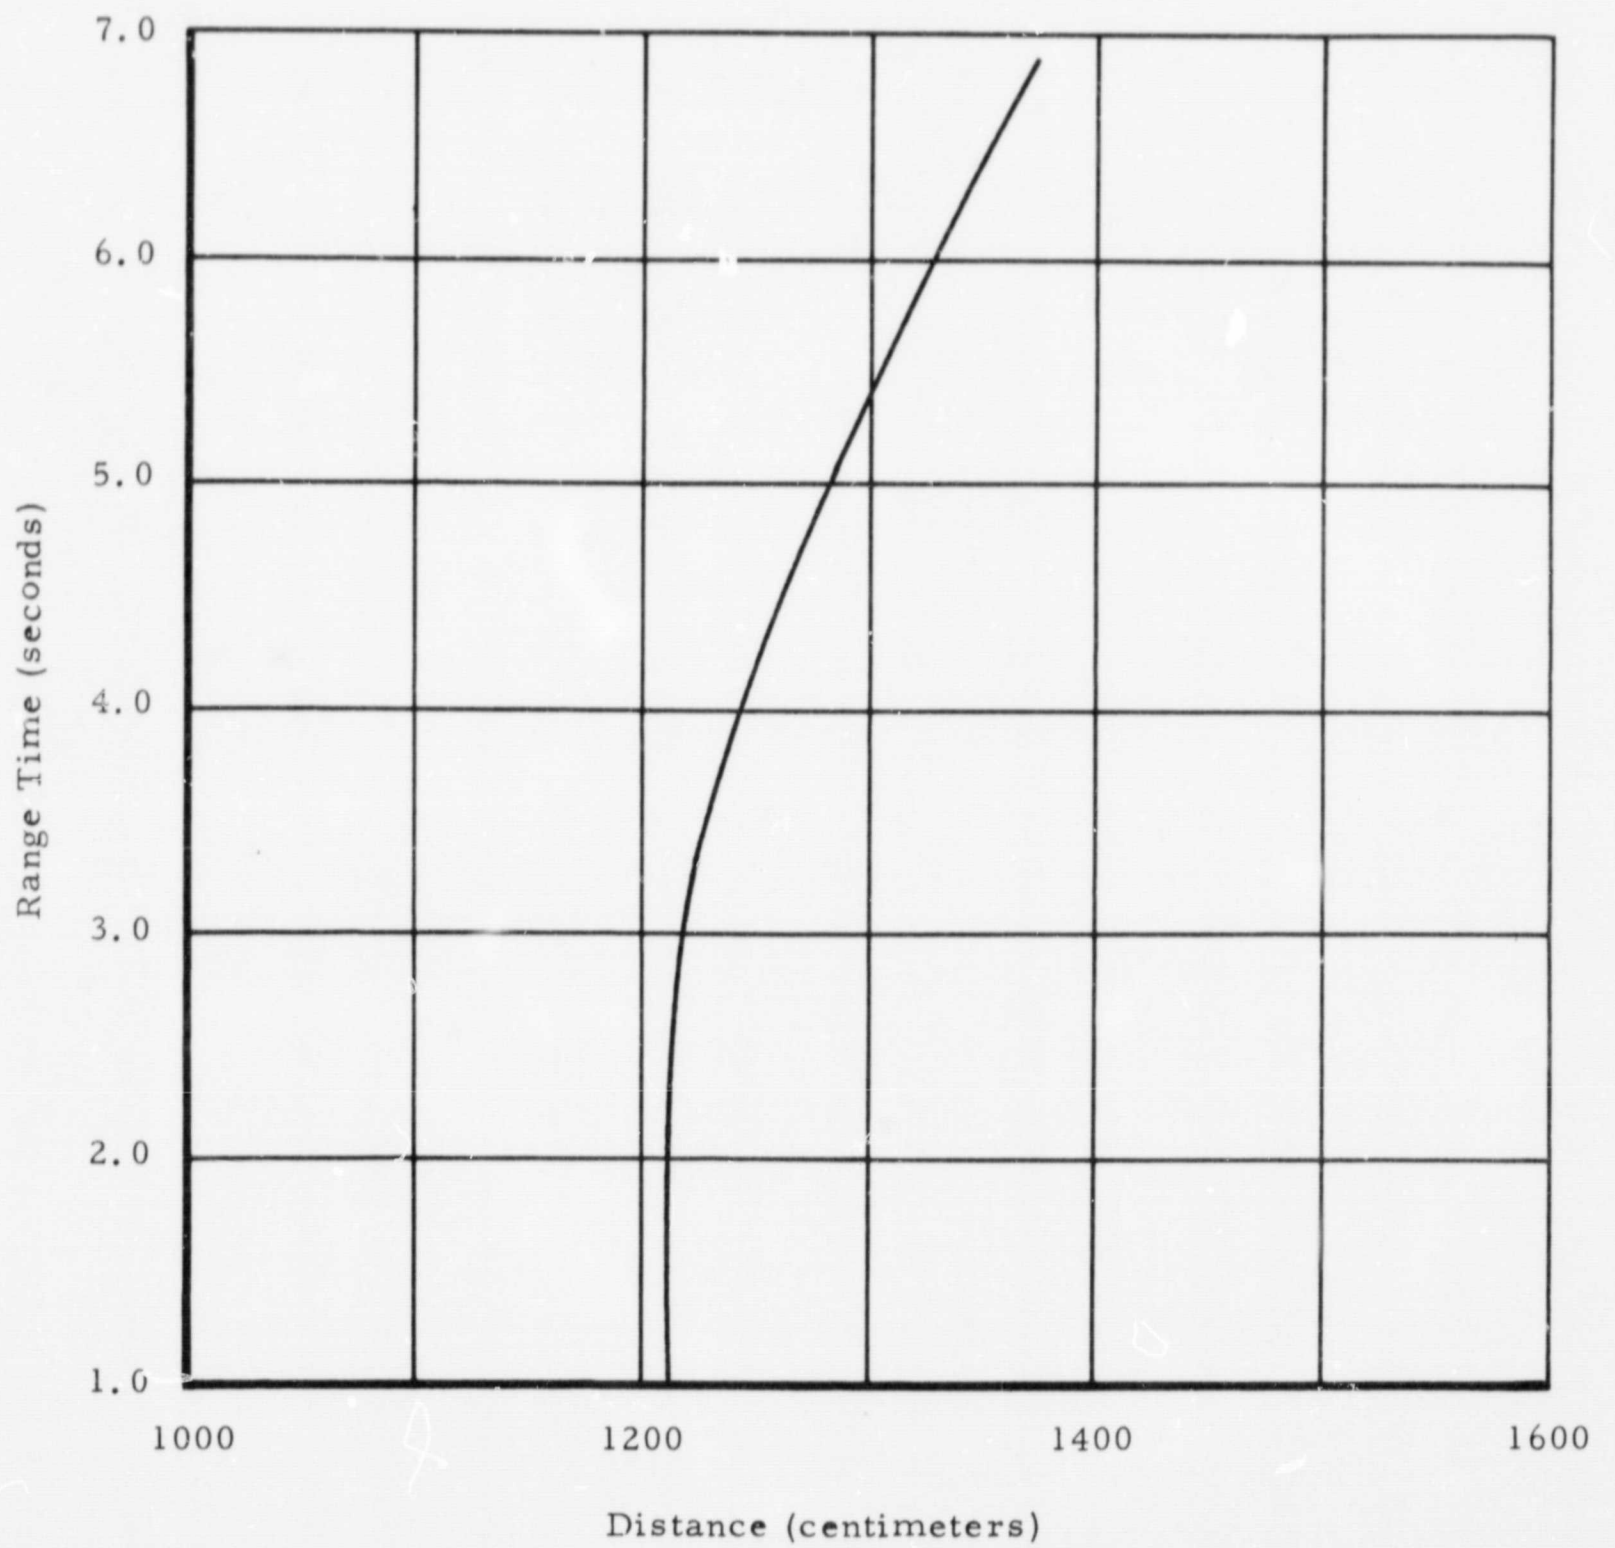
FIGURE 8. VEHICLE LATERAL MOTION
(Distance Between the Centerline of the Vehicle
and the Centerline of the Umbilical Tower)

One camera was programmed to observe any gross lateral motion of the vehicle and to record tower clearance time. This camera operated as programmed and usable data were obtained. No unusual lateral motion of the vehicle was observed (Figures 8 and 9).

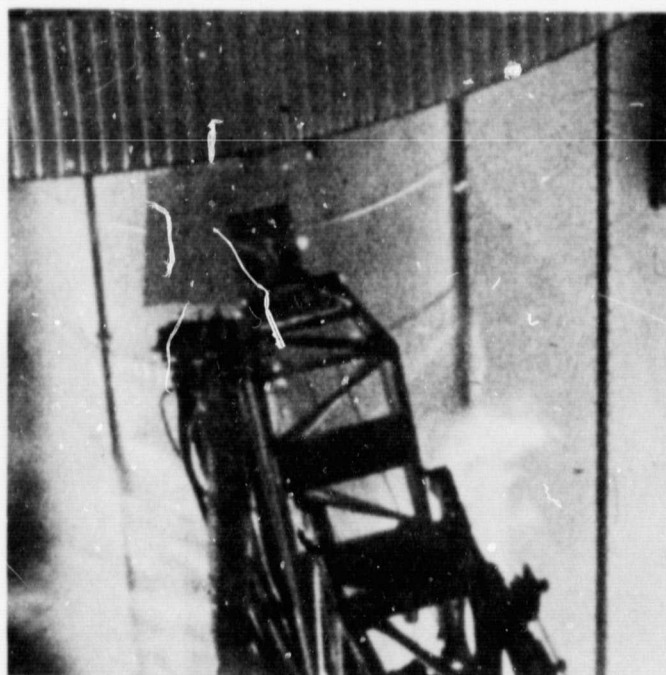
FIGURE 22. TYPICAL SWING ARM DISCONNECT

Sixteen cameras were programmed to cover the release and retraction of the four swing arms. Eight were used to observe disconnect (Figure 22); four were used to obtain swing arm/vehicle clearance and four to obtain swing arm retraction rates (Figures 23 and 24). The cameras produced technically usable data with the following exceptions; one camera was out of focus and the time of the release could not be determined; one camera had a timing dropout after nine seconds; however, a time extrapolation produced the retraction rate; the cover panel at swing arm three connect point struck the swing arm head after release (Figure 25); the cover panel at swing arm one was observed not to close completely (Figure 26); the retraction rate of swing arm one was not obtained due to ice and frost in the field of view and on the quartz window. The release of each arm was referenced to the first frame of data showing continuous motion of the umbilical head. Figures 27 through 32 depict the angular displacement and velocity of swing arms two, three, and four.

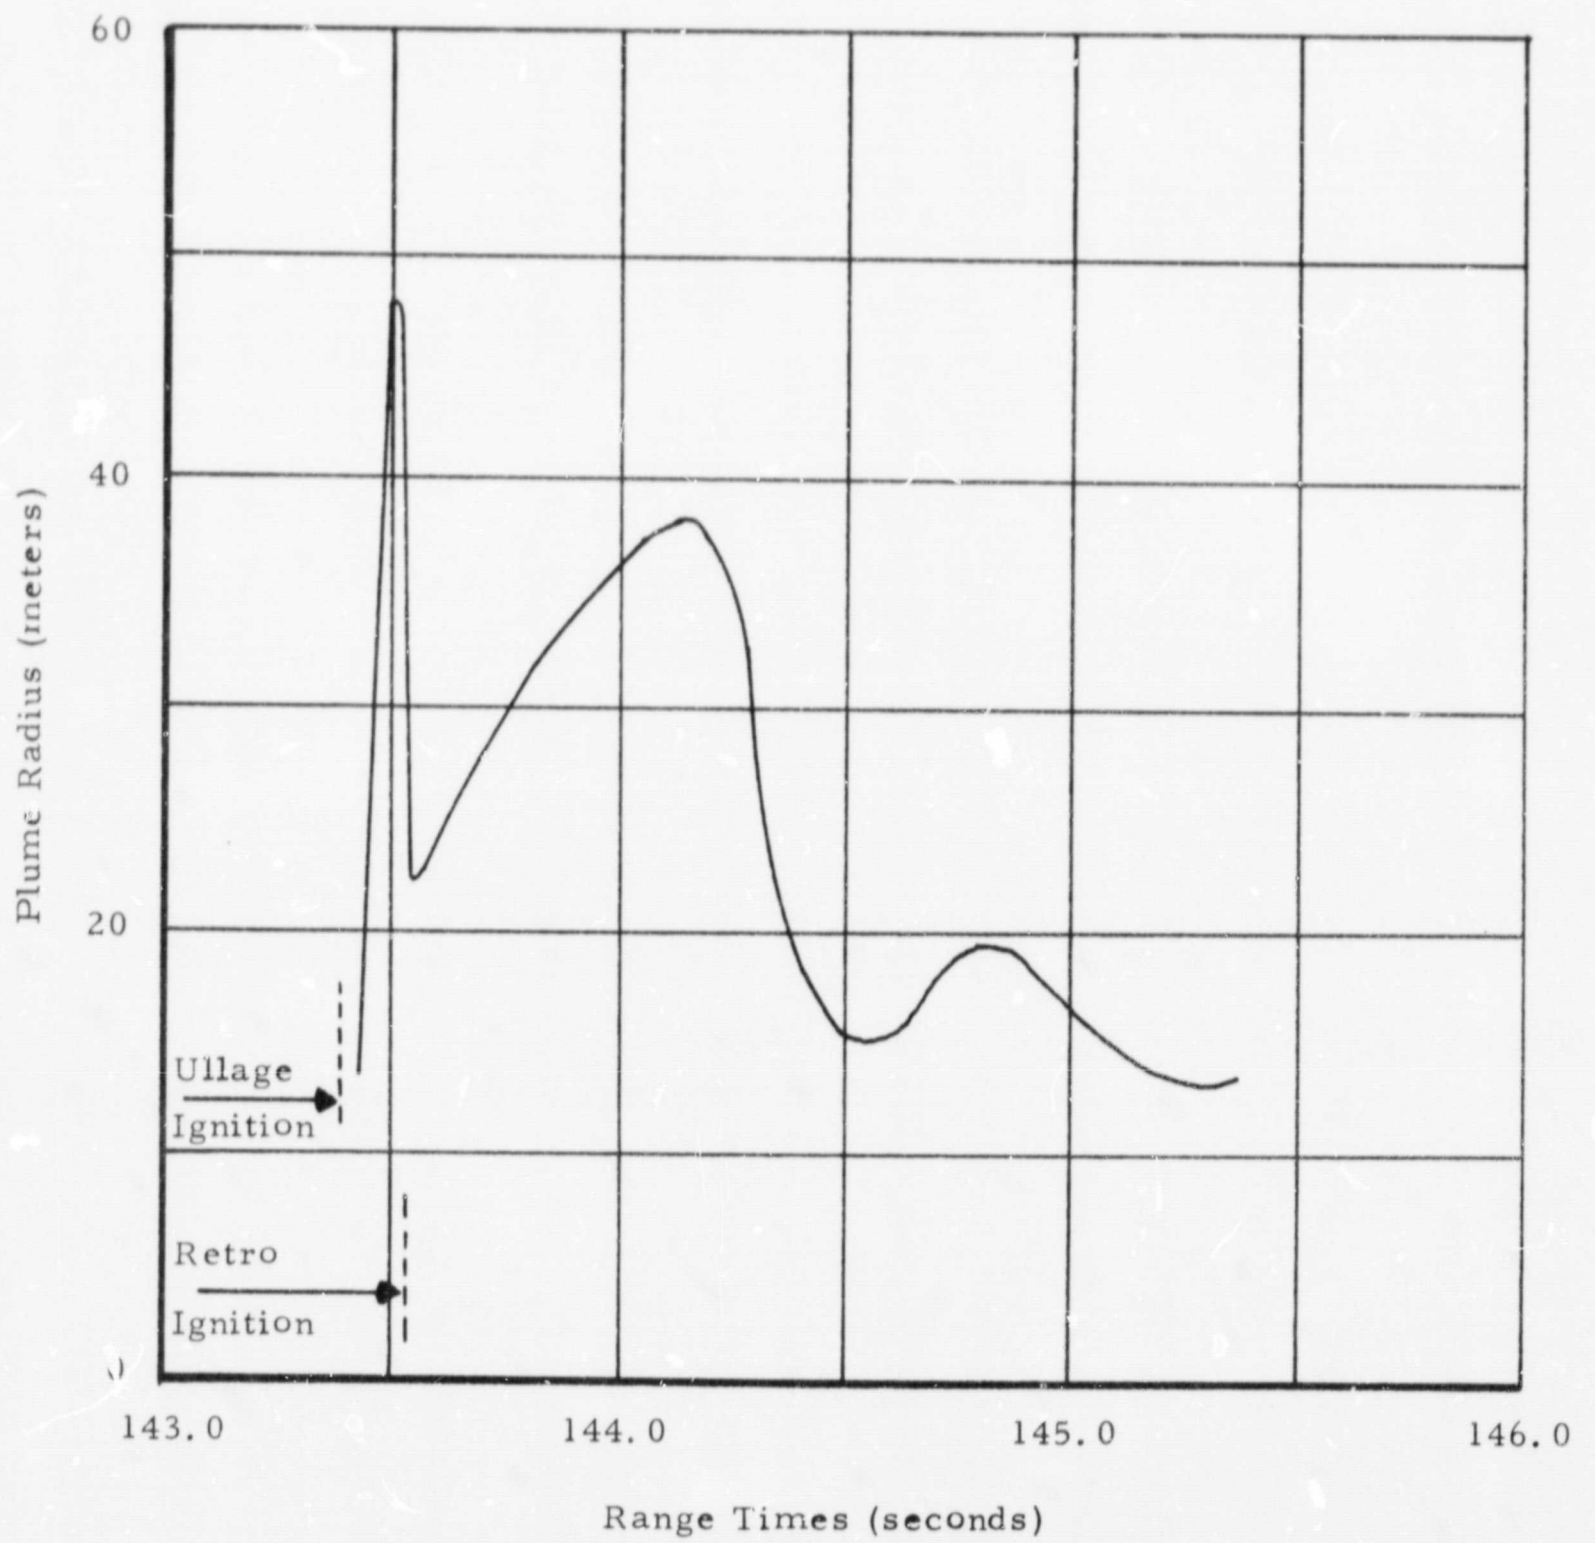
FIGURE 35. RETROROCKET EXHAUST PLUME

Three cameras were programmed to follow the S-IB stage until the entire vehicle comes into view and then track until loss of view. Some staging events were timed and no malfunctions were observed (Figure 35).

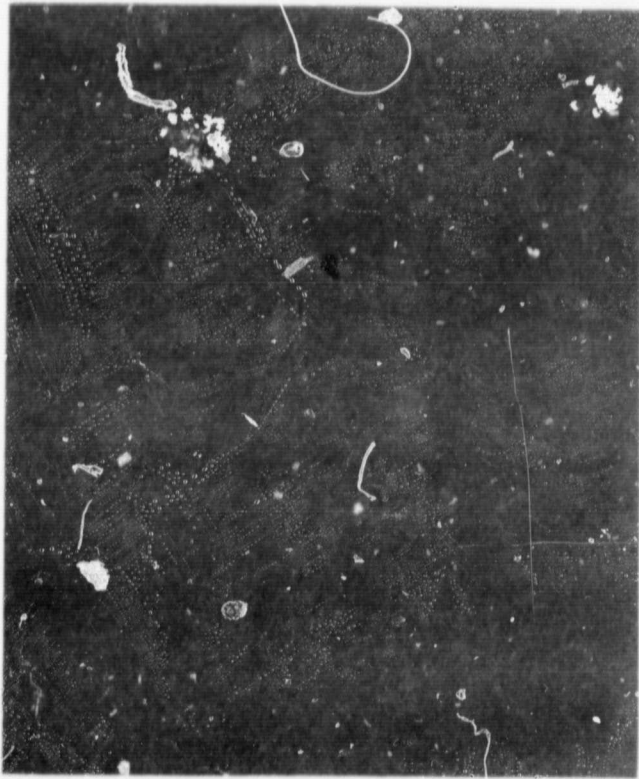
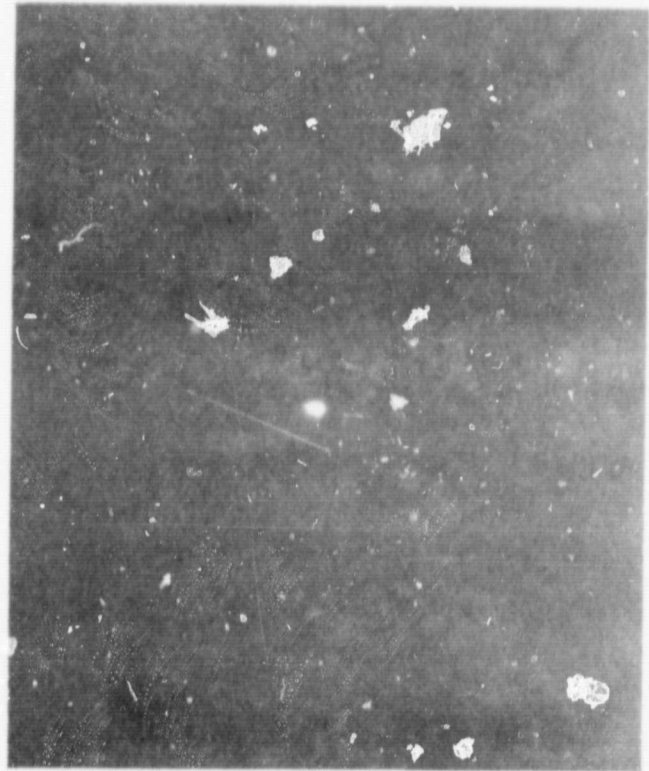
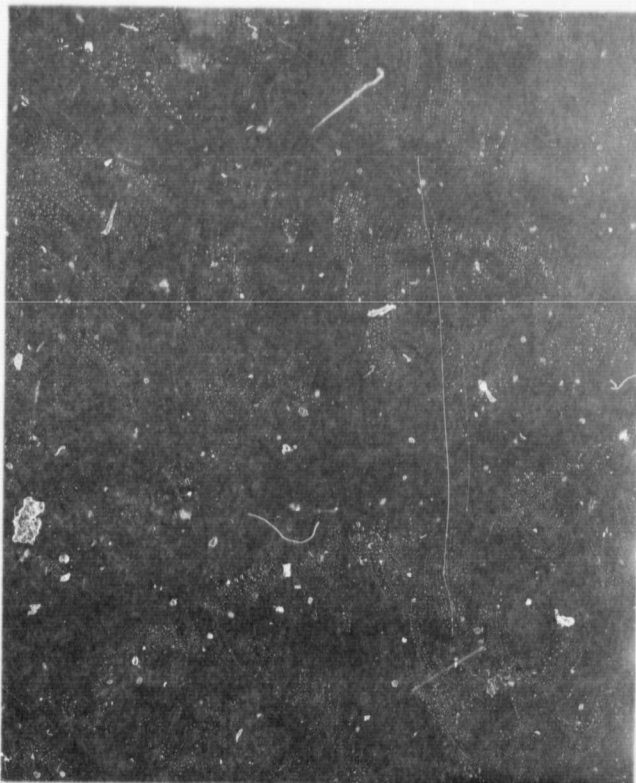
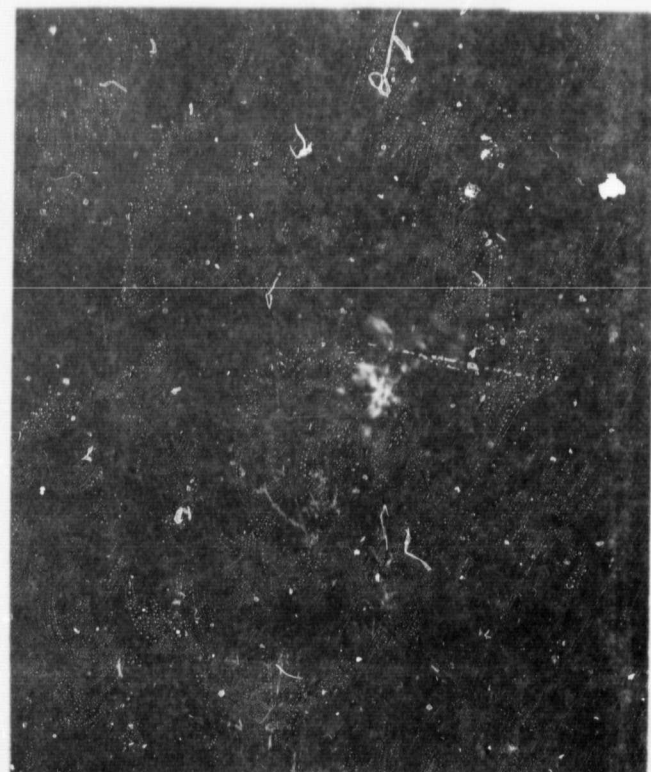
FIGURE 36. S-IB/S-IVB SEPARATION SEQUENCE

separation sequence was timed from each camera and the times correlated (Figures 36 and 37). One of these cameras was linked with the real time television network.
